Evaluation of internal void volume in resin composites with different restorative techniques by micro-computed tomography

Pongtakorn Sermsopit¹, Chantapat Yangyuen¹, Paniti Snabboon¹, Pirat Karntiang²

¹College of Dental Medicine, Rangsit University, Pathumthani, Thailand

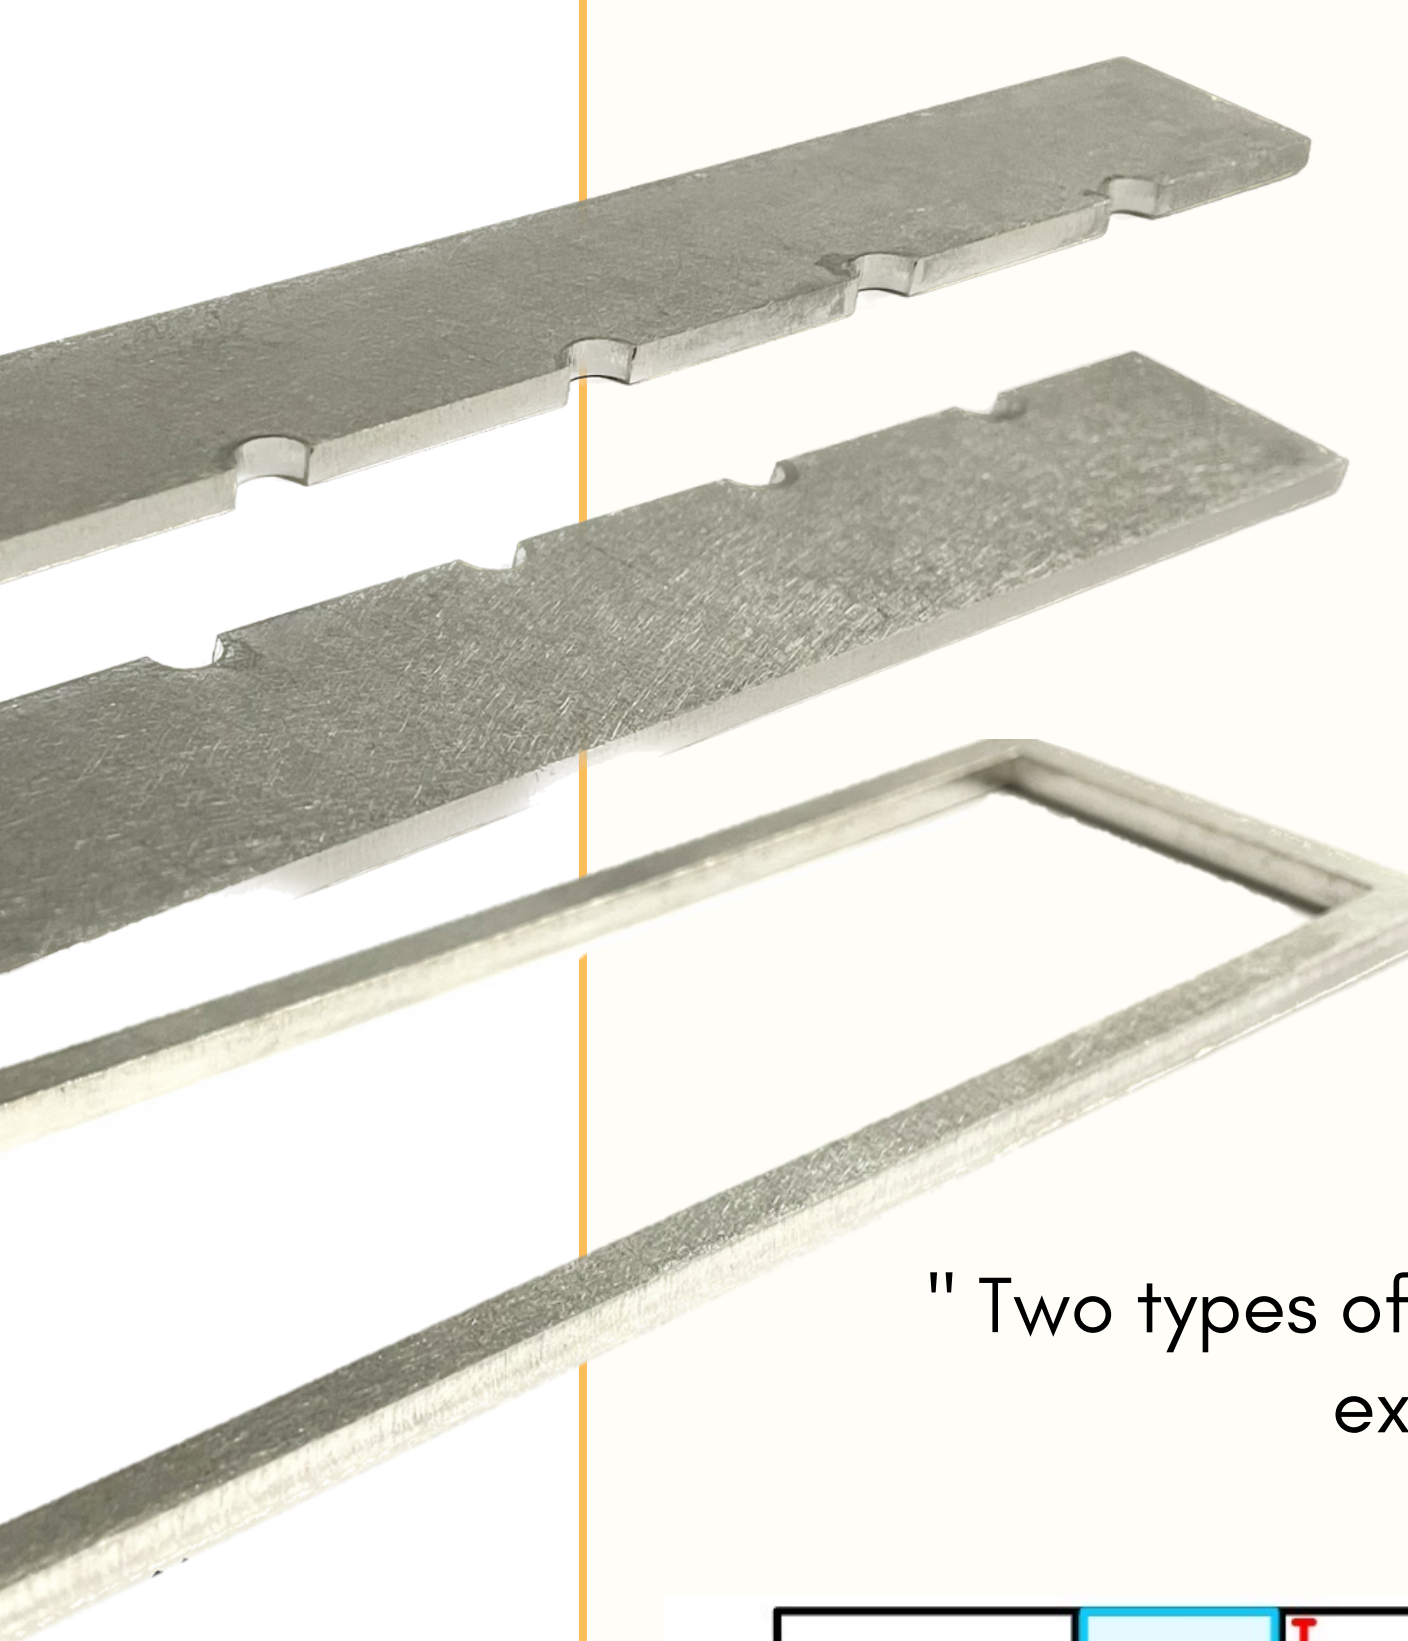
Stainless steel mold
1, 2, 3 mm

Stainless steel
frame

"Two types of resin composite were used to fabricate specimens according to the experimental groups using stainless-steel cylindrical mold."

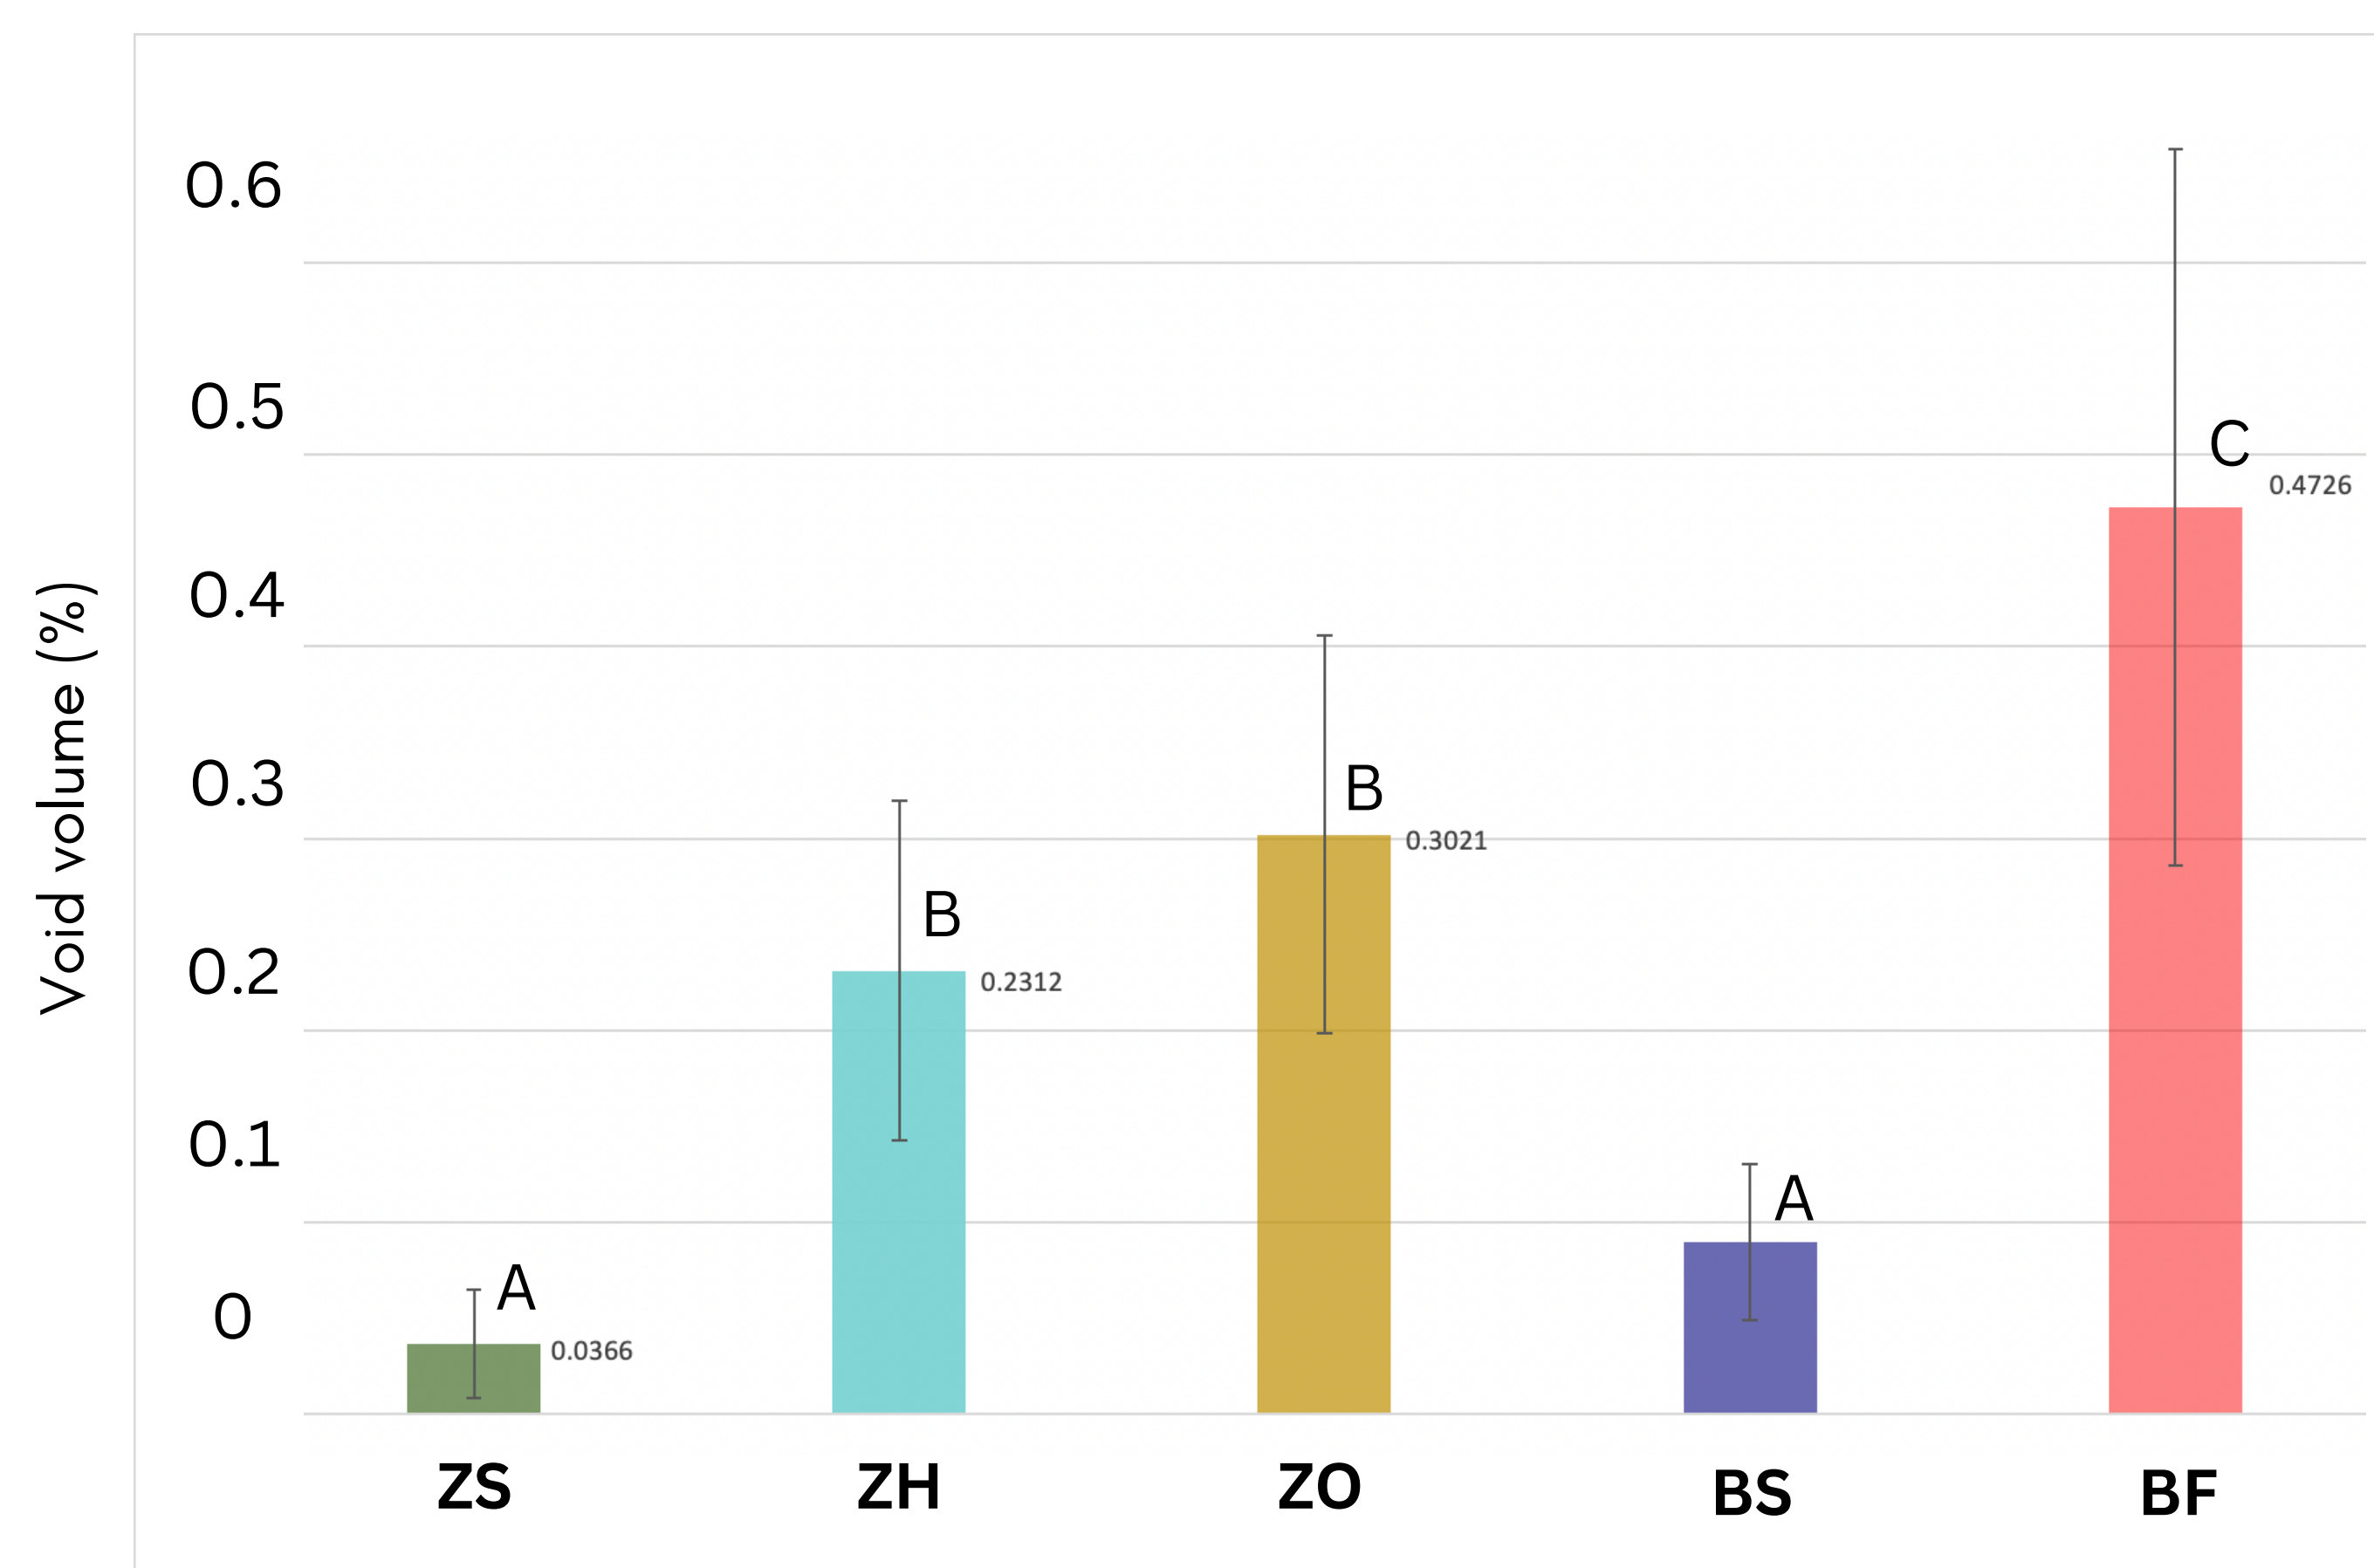
Different letters indicate statistical significance differences among groups regarding mean percentage of void volume

- Group BF significantly showed the most void formation ($0.4726 \pm 0.1866\%$) among all the tested groups ($p=0.05$).
- Group ZS and BS showed the least void formation ($p=0.05$) (ZS = $0.0366 \pm 0.0279\%$ and BS = $0.0895 \pm 0.0405\%$ respectively).
