Effect of Different Neutralizing Agents on Feldspathic Porcelain Etched by Hydrofluoric Acid

Eur J Dent 2019;13:75–81

Objective The aim of this study was to evaluate the effect of neutralizing agents on the shear bond strength of hydrofluoric (HF)–etched porcelain in nonaging and aging conditions.

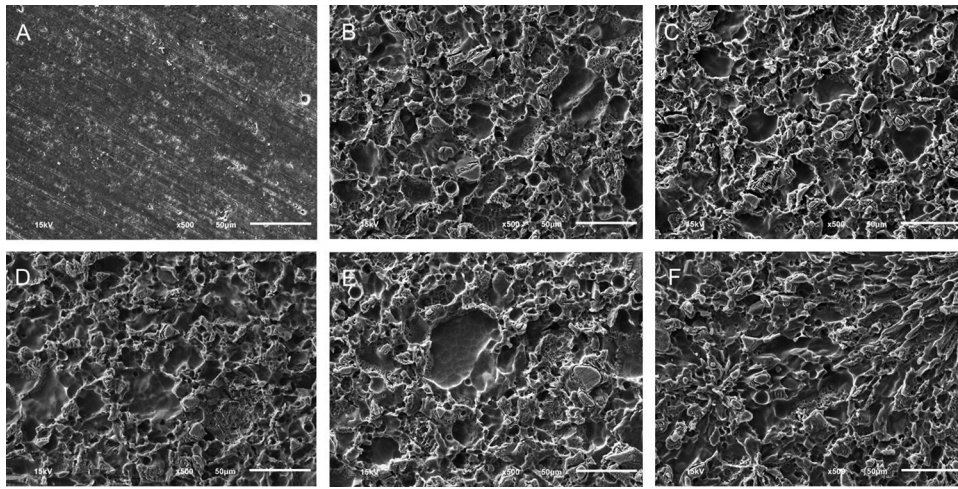
Fig. 1 The scanning electron microscope images of the porcelain with different surface treatments at $\times 500$: (a) Control, (b) hydrofluoric, (c) hydrofluoric and calcium hydroxide, (d) hydrofluoric and calcium carbonate, (e) hydrofluoric and calcium gluconate, and (f) hydrofluoric and ultrasonic cleaning.

The SEM images at $\times 500$ and $\times 2,000$ magnification of the samples from each experimental group after surface treatment are shown in ►Figs. 1 and 2. The nonetched porcelain surface of the control group exhibited a smooth-flat surface with slight porosity and polishing groove formations (►Figs. 1a and 2a).

Etching with 9.5% HF acid for 90 s resulted in a morphological honeycomb-like surface with shallow irregularities, microporosities, and grooves as shown in ►Figs. 1b and 2b. SEM photographs of experimental Groups 3–6 showed irregular morphology similar to that of Group 2 (►Fig. 1c-f). In addition, high magnification of the surface irregularities of all experimental groups demonstrated no debris or acid-etched residue (►Fig. 2c-f).

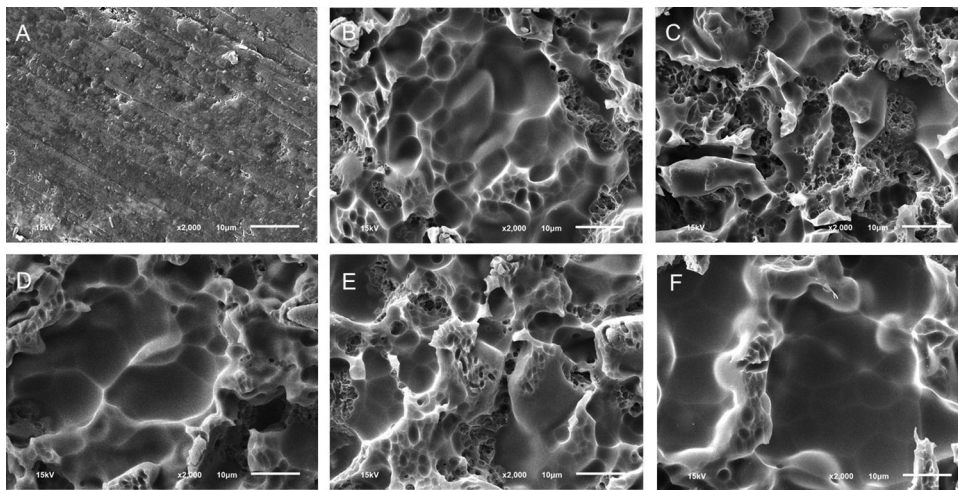
Fig. 2 The scanning electron microscope images of the porcelain with different surface treatments at $\times 2000$: (a) Control, (b) hydrofluoric, (c) hydrofluoric and calcium hydroxide, (d) hydrofluoric and calcium carbonate, (e) hydrofluoric and calcium gluconate, and (f) hydrofluoric and ultrasonic cleaning.

The SEM image showed that HF-etched porcelain, after neutralization with various substances and cleaned with water spray, demonstrated a clean surface with no acid–base reaction residue, similar to the group that was ultrasonically cleaned. This was significant as many studies have reported that ultrasonic cleaning after etching with HF resulted in maximum cleansing and optimal bond strength.^{25–27}

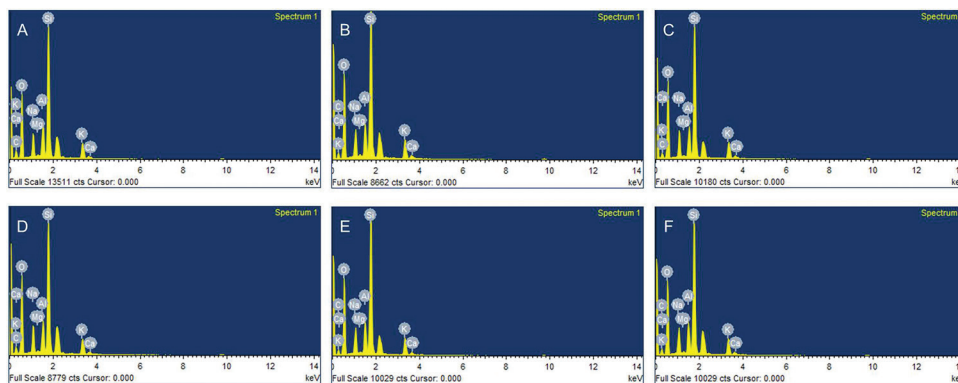
Fig. 3 The energy-dispersive X-ray spectra of the porcelain with different surface treatments: (a) Control, (b) hydrofluoric, (c) hydrofluoric and calcium hydroxide, (d) hydrofluoric and calcium carbonate, (e) hydrofluoric and calcium gluconate, and (f) hydrofluoric and ultrasonic cleaning.

EDX analyses of the treated surfaces of each group are shown in ►Fig. 3. The control group demonstrated peaks in C, O, Na, Mg, Al, Si, K, and Ca spectra at 0.2774 (K α), 0.5249 (K α), 1.0410 (K α), 1.2536 (K α), 1.4866 (K α), 1.7398 (K α), 3.3129 (K α), and 3.6905 (K α) keV, respectively. In addition, HF-etched porcelain showed identical spectra to the control group. However, F element, with a peak at 0.6768 (K α) keV, was not found on any of the specimens.

However, according to the EDX readings of our study, only C, O, Na, Mg, Al, Si, K, and Ca ions were found in all groups. Fluorine ion was not found in any group. This might be because the fluorine and calcium ion present in the neutralizing agent were bound to the fluorine ion on the surface of the sample, which was rinsed away by the water spray or ultrasonic.
